U.S. Army Garrison
Aberdeen Proving Grounds (APG)

CWA Inspection 9/16/14

EPA Inspector

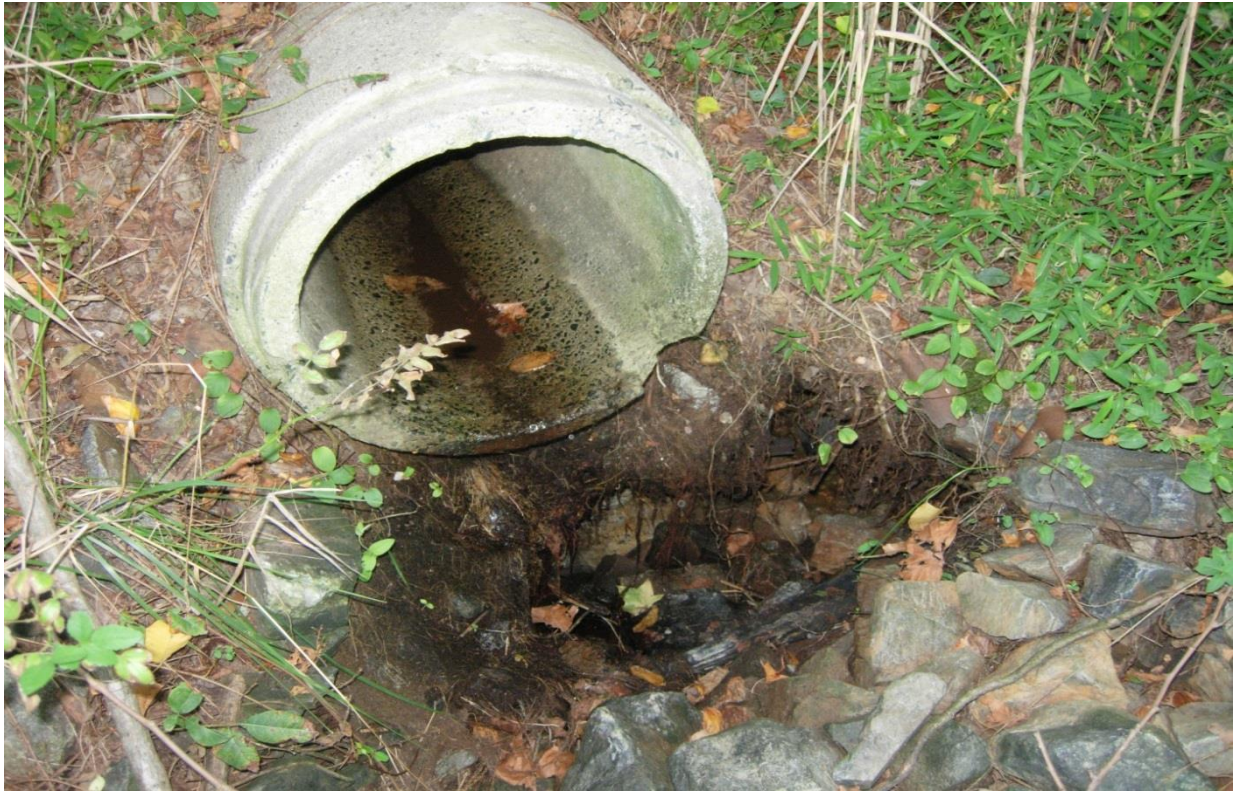
At the time of inspection, this inspector noted erosion under the outfall piping. (See Photo 1) Under the APG Stormwater Pollution Prevention Plan Section 6.1.1 – Preventative Maintenance, the facility is required to perform corrective maintenance on this outfall.

Photo 1- Structural erosion below Outfall #014 - Bush River

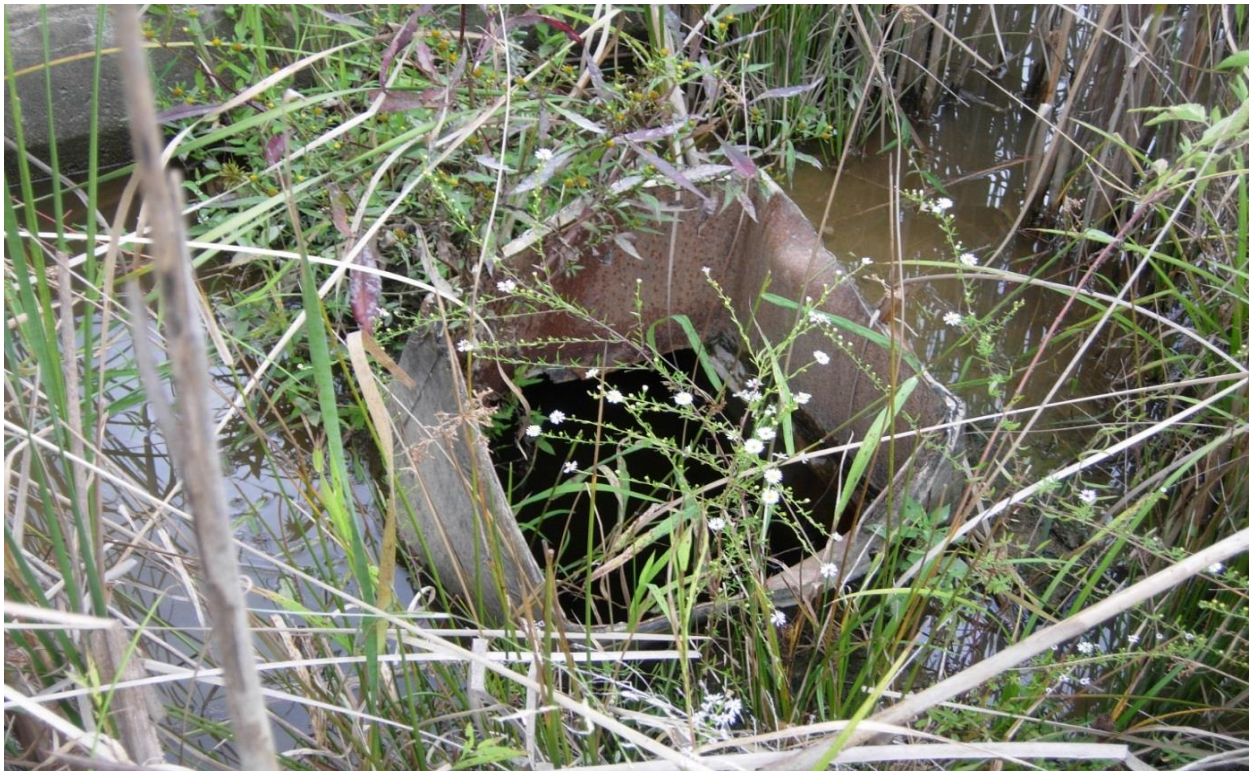
At the time of inspection, this inspector heard the sound of water entering into the drainage pipe (See Photo 2) that exits on the opposite side of a berm into a drainage area. At the time of inspection, the vegetation was very high and this inspector could not see where the water exited into the pond. At the time of inspection, the water level in the drainage area was low. However, previous high water level marks on the soil and bent vegetative growth shows a pattern of water flow exiting the drainage area towards Sod Run. This inspector has a concern that the “closed loop” is not fully closed and during heavy rainfall events, discharges may reach Sod Run.

Photo 2 - Outfall #007 exit point to outside drainage area.

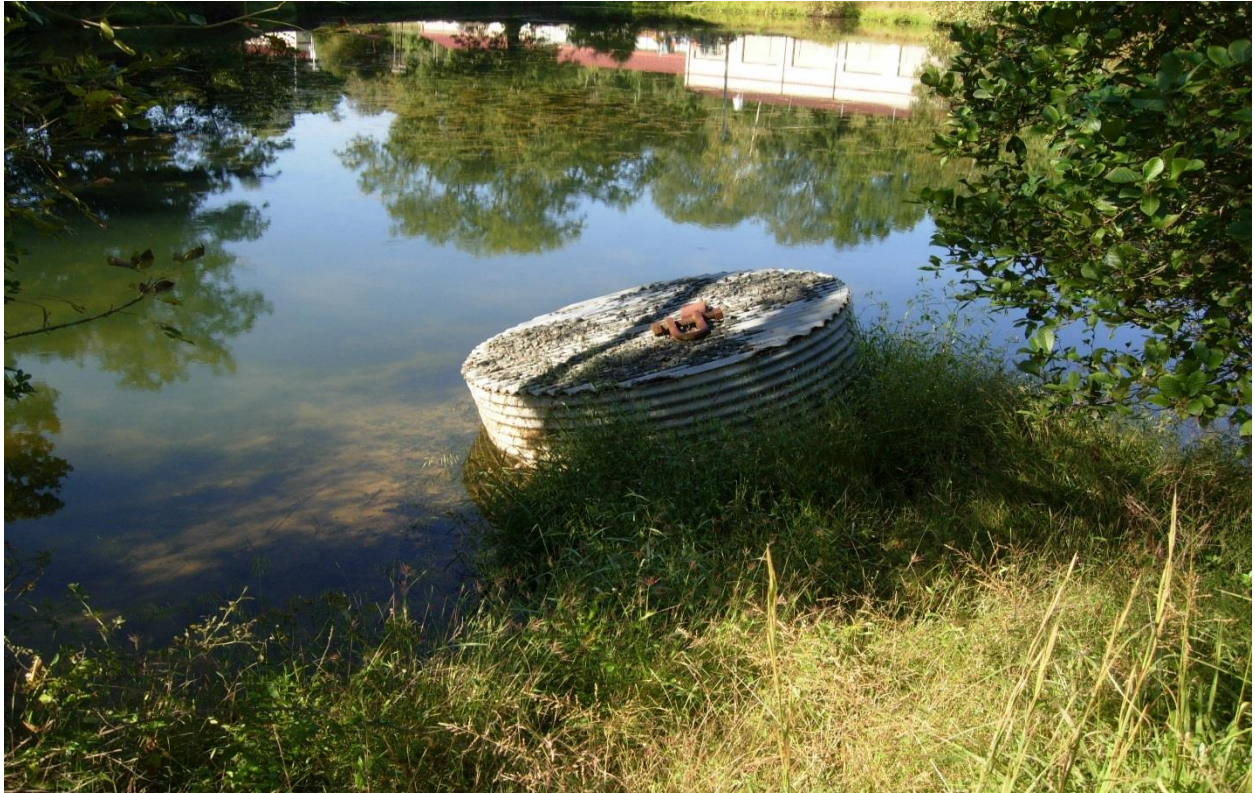
At the time of inspection, this inspector's area of concern was the broken intake inside the Sedimentation Pond.

Photo 3 - Outfall #005 - Broken intake in sedimentation pond.

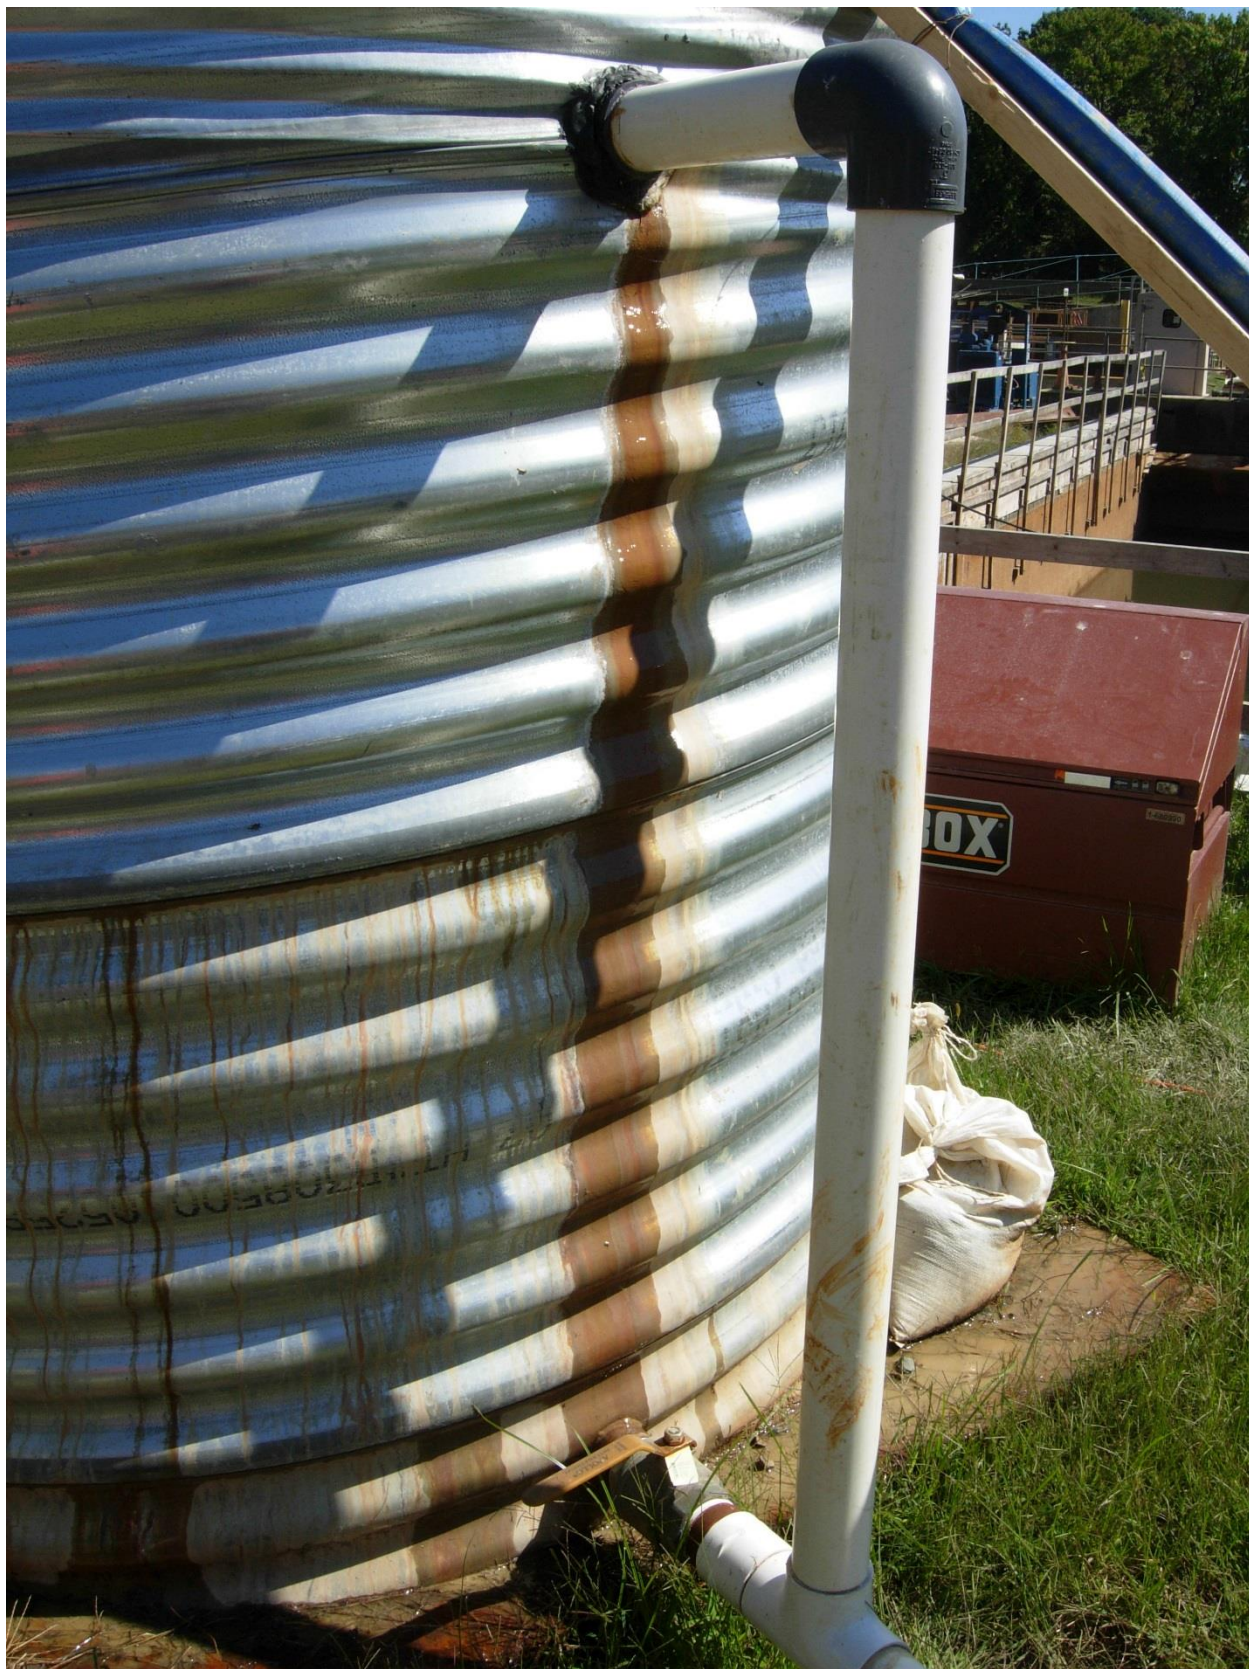
Areas of concern at the Edgewood WWTP for this inspector include a leaking raw influent tank made of zinc (see Photo 4). The leaking has been going on long enough to rust the side of the tank. The discharging influent gathers into a puddle in the grass around the base of the tank. Rainfall events would cause this puddle to grow and flow down slope towards the perimeter of the WWTP.

Photo 4 - Untreated influent wastewater leaking from collection tank.

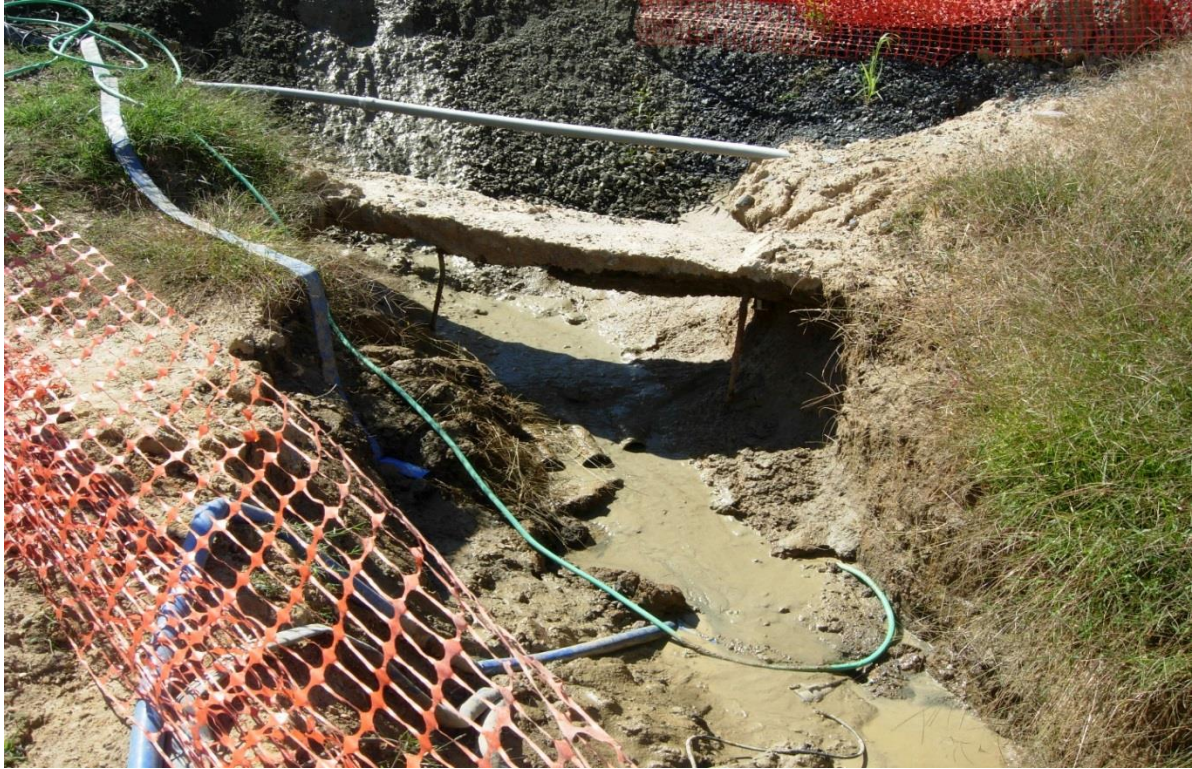
Adjacent to the leaking zinc tank is a trench that goes under the service road and collects stormwater (see Photo 5). The blue hoses and PVC piping that connects the influent wastewater to the zinc tank has some leakage that gathers in the trench along with any stormwater. The contractor pumps the muddy water into the primary clarifier. If the mud is too thick to pump out, water is added with a garden hose to increase viscosity. The area of concern is the mixture of raw influent and stormwater exiting the trench area and into the surrounding grass (see Photo 6).

Photo 5 - Trench adjacent to leaking collection tank collecting stormwater and leaking influent.

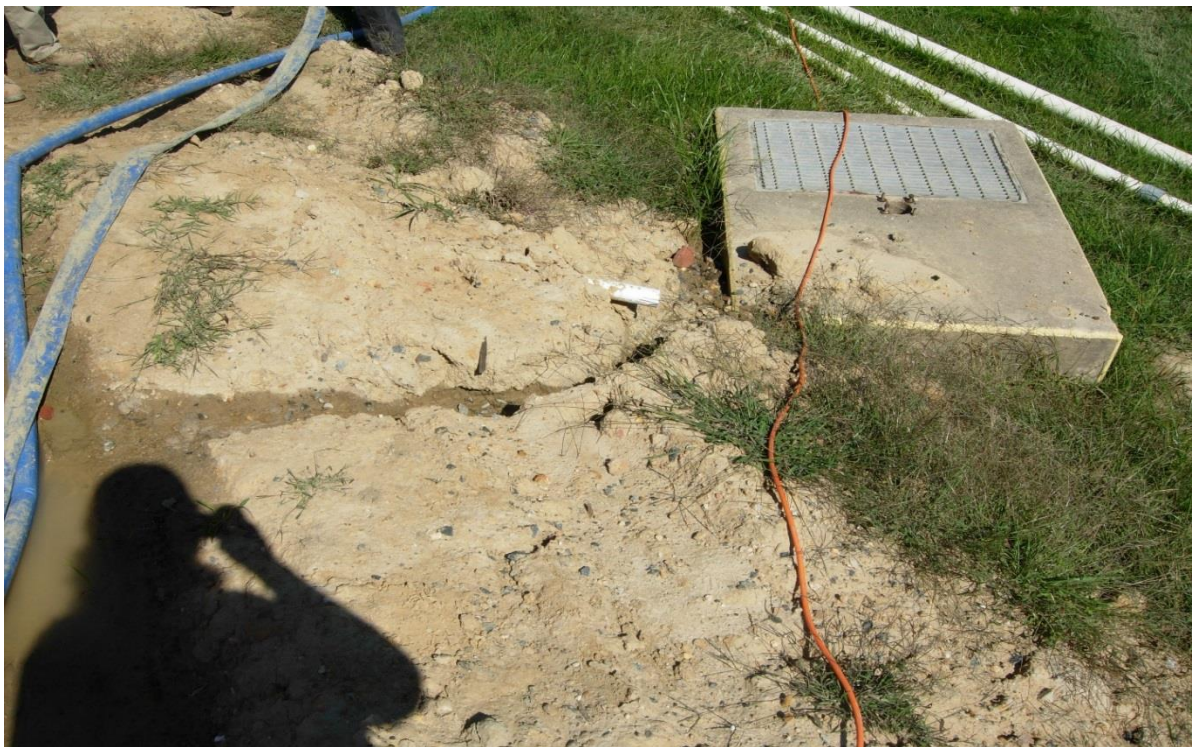
Photo 6 - Influent from trench entering grassy area.

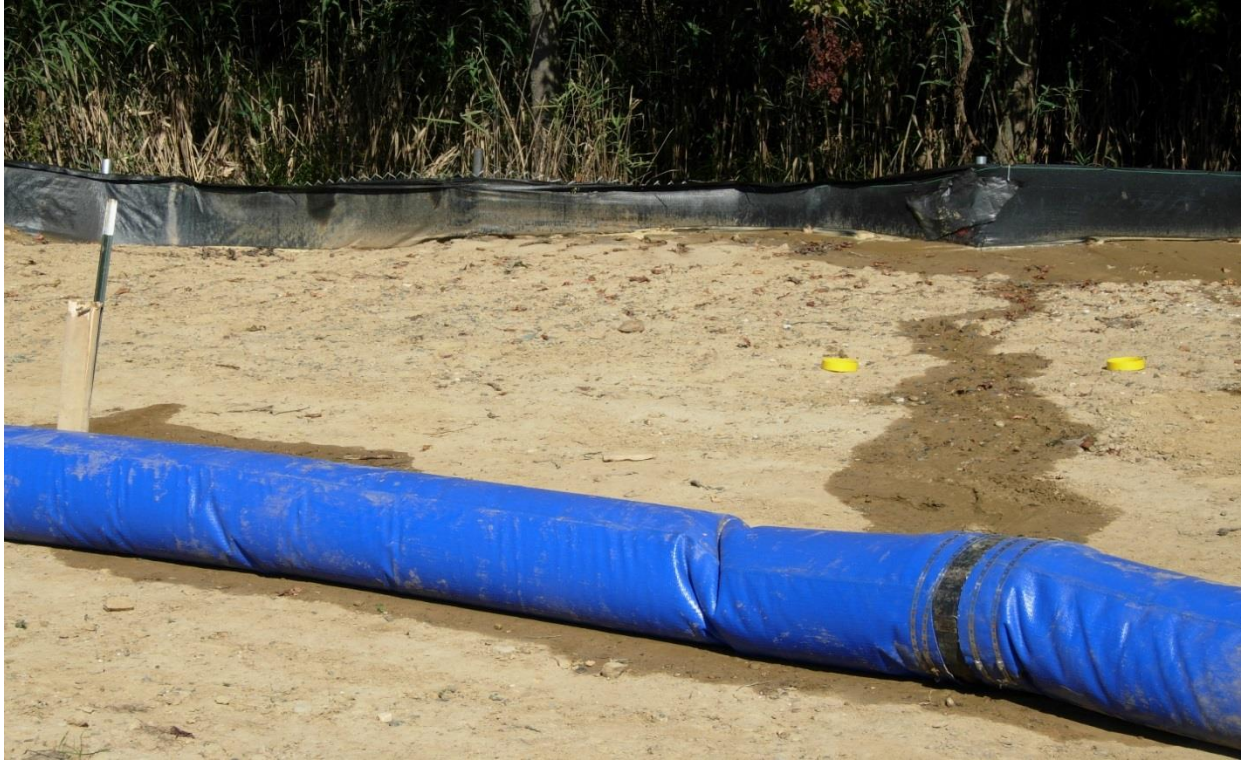
After the primary clarifiers and sedimentation tanks, the wastewater is generally passed through filtration before disinfection. During the inspection, the filtration process was bypassed to disinfection by using a large, blue rubber hose (see Photo 7). At the time of inspection, there were three distinct areas of leakage coming from the hose. Photos 8 and 9 show the areas along the silt fencing where the untreated wastewater leaking from the blue hose is discharging off site.

Photo 7- Untreated influent leaking from a hose that is bypassing the filtration on its way to the clarifier.

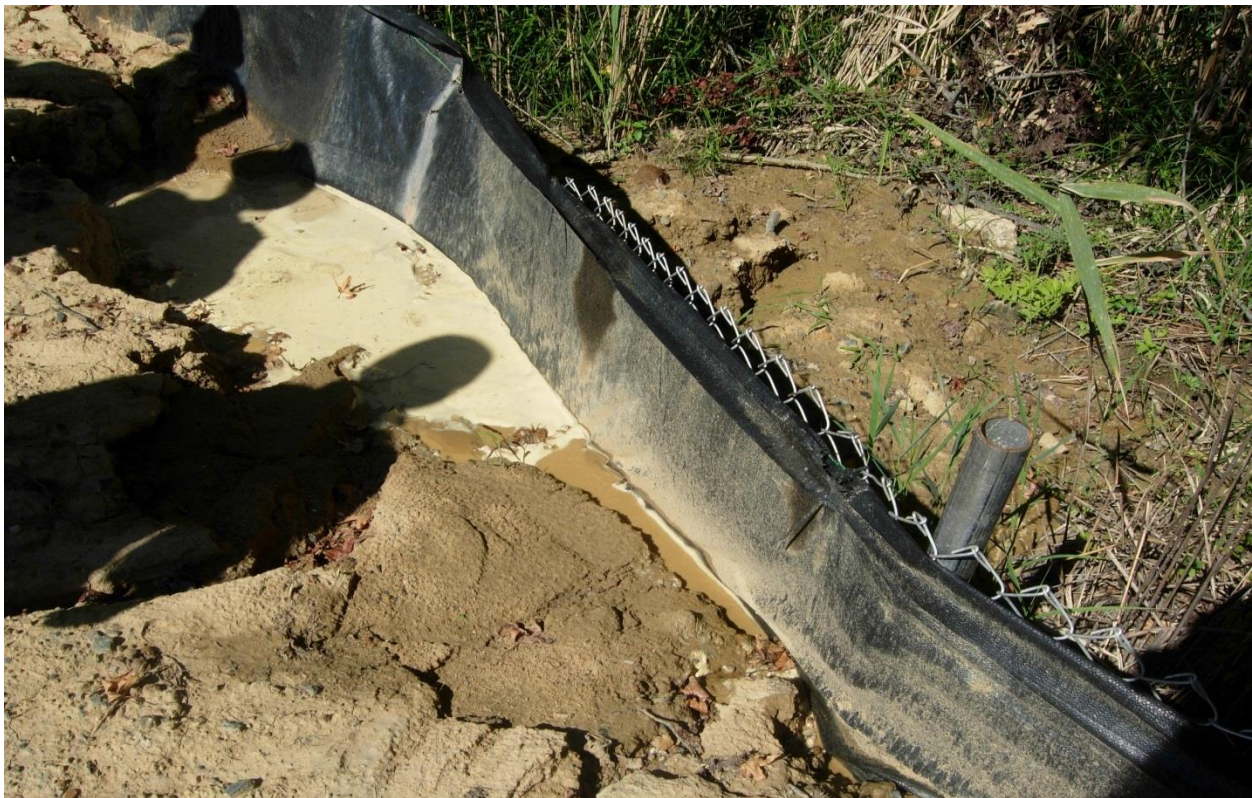
Photo 8 - Untreated Influent from leaking blue hose by passing silt fencing.

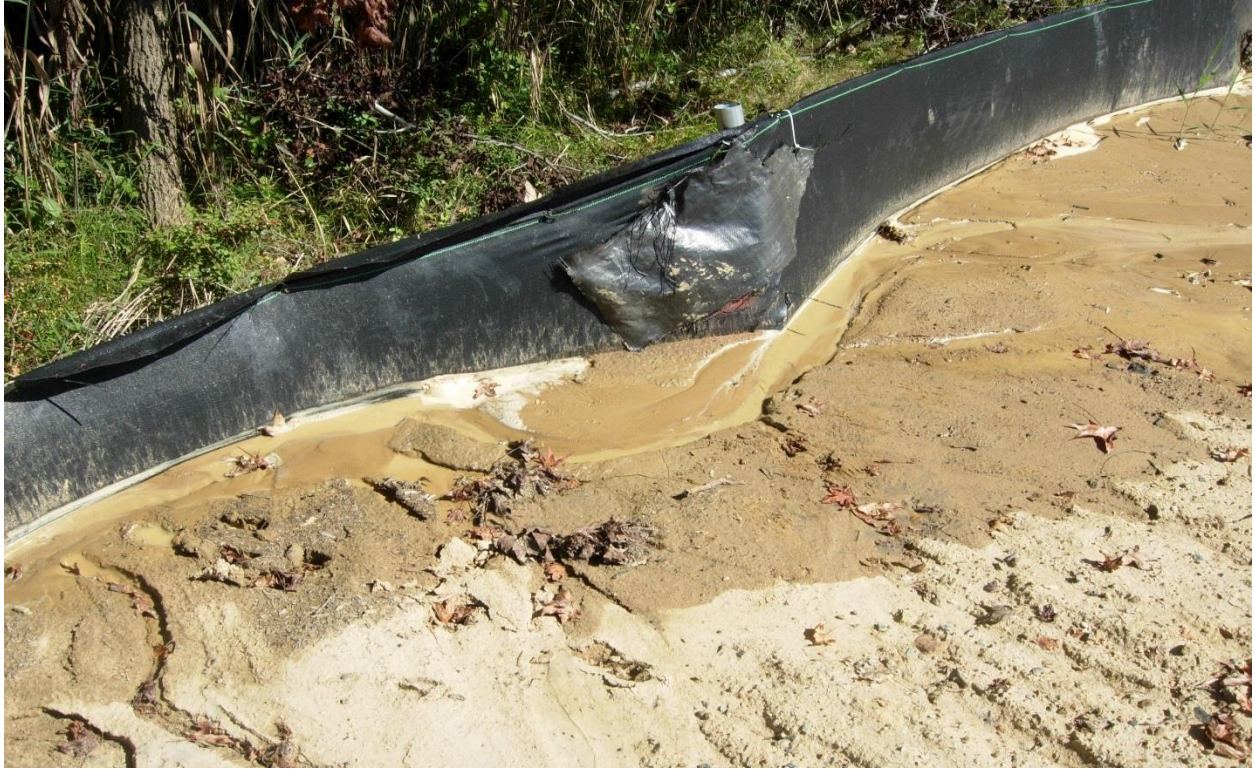
Photo 9 - Leaking influent from blue hose discharging under silt fencing.

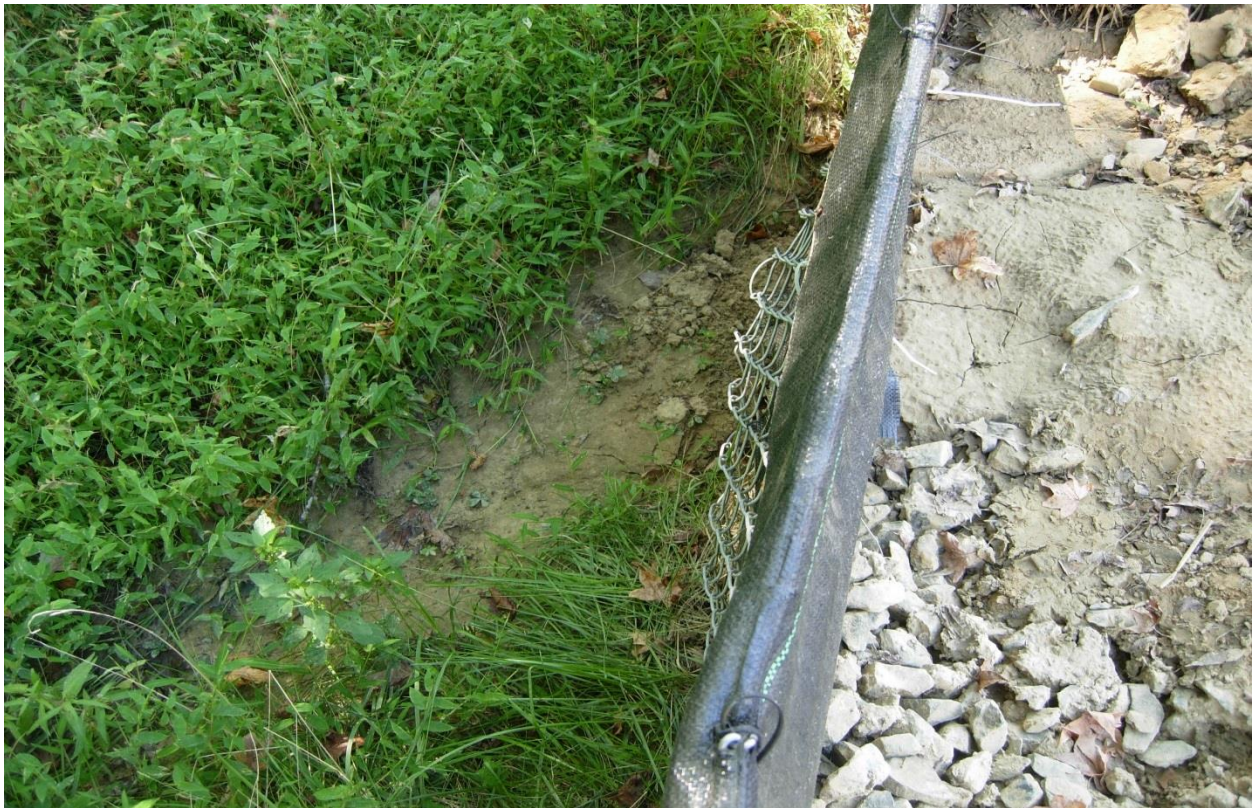
Other areas of concern related to the WWTP are Best Management and House Keeping issues. Photos 10 and 11 show inadequate silt fencing in need of maintenance. The WWTP is bordered by the Chesapeake Bay on the backside of the property. The contractor uses the grassy area next to the Bay as a storage and set up area for materials. At the time of inspection, there were numerous paint cans (see Photo 12), plastic bottles, and food wrappers littered around the area and along the water's edge.

Photo 10 - Silt fencing in need of maintenance.

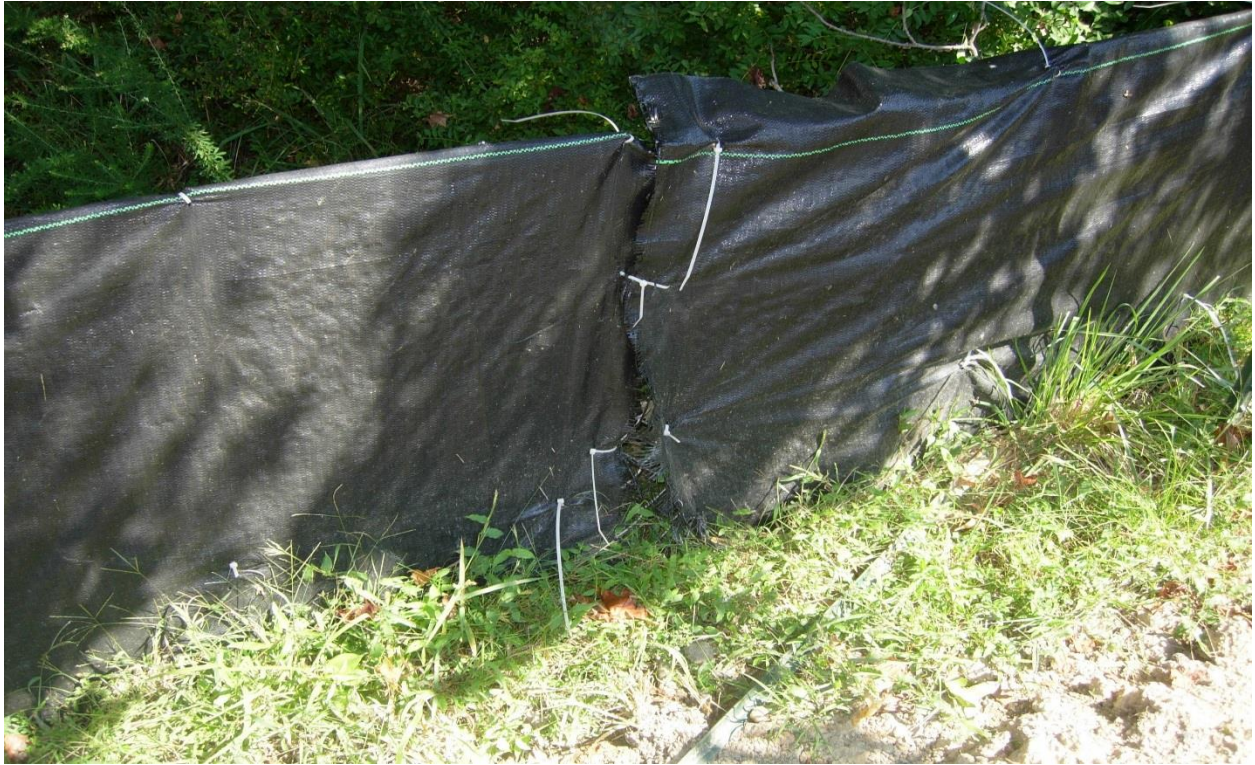
Photo 11 - Silt fencing improperly maintained.

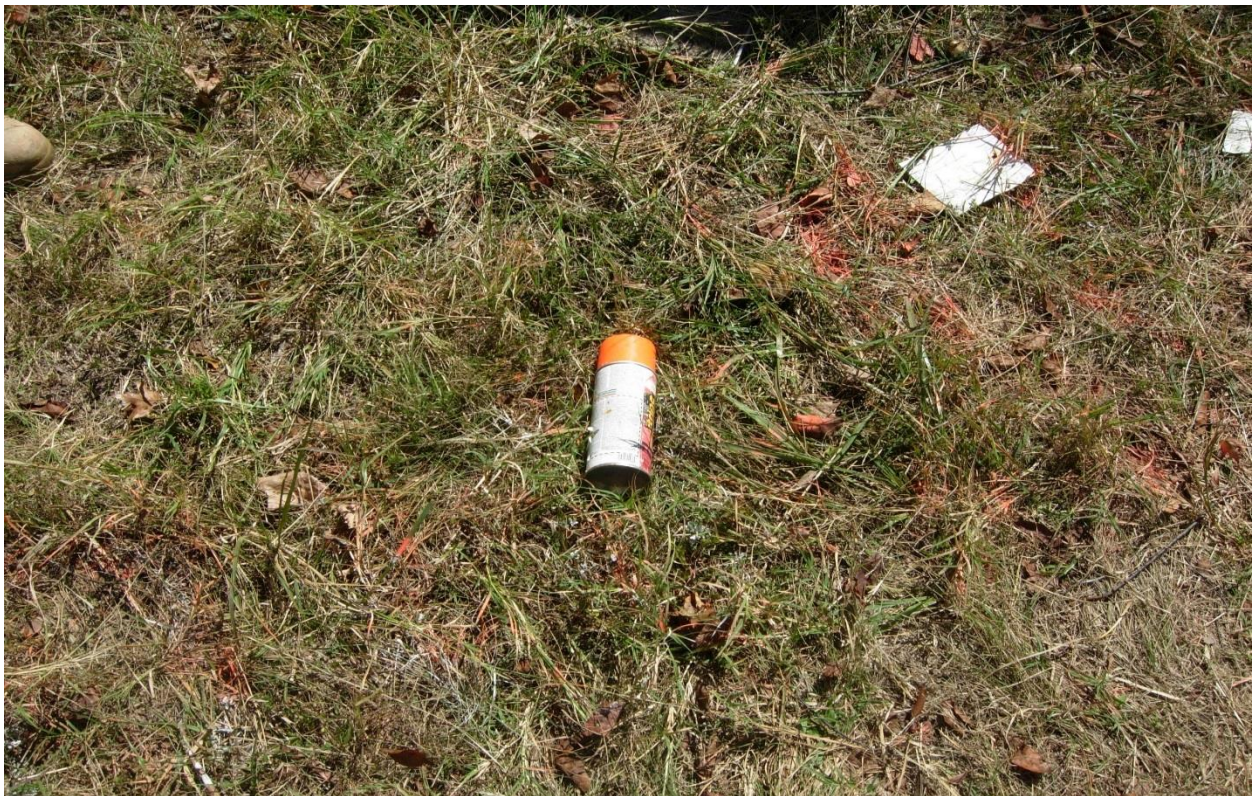
Photo 12 - One of many paint cans, plastic bottles, and general trash within 5-15 yards from the Chesapeake Bay.
